Vitrified Clay Pipe Corrosion

Webinar, 24-Sep-2020 12:00 Noon

LOS ANGELES COUNTY SANITATION DISTRICTS (LACSD)

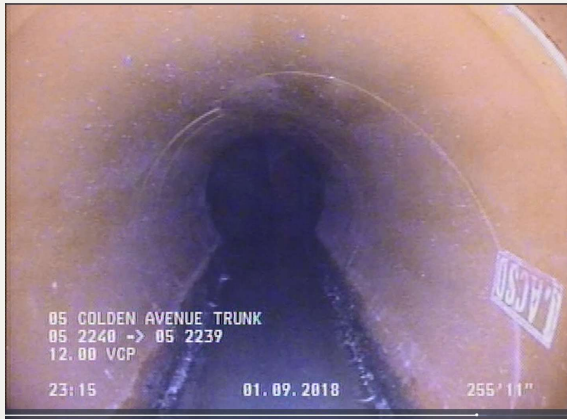
Condition "3"
Monitor for damage

10+ year repair
timeframe

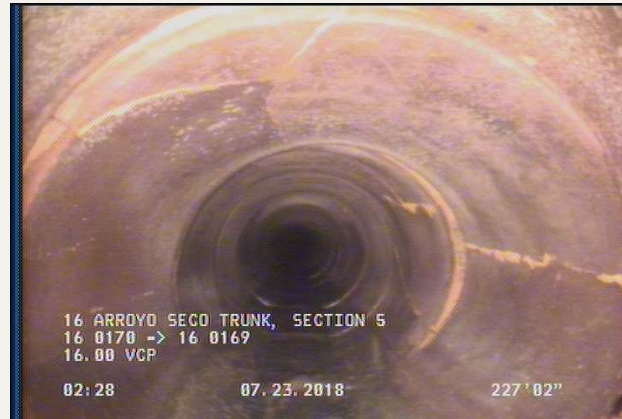
Condition "2"
Repair: Secondary priority

6-10 year repair timeframe

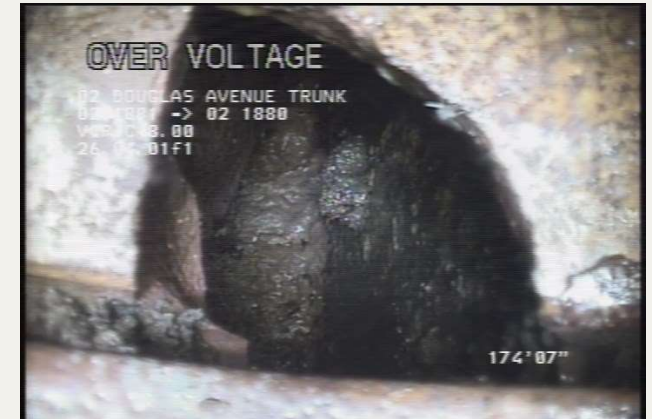
Condition "1"
Repair: High priority

0-5 year repair timeframe

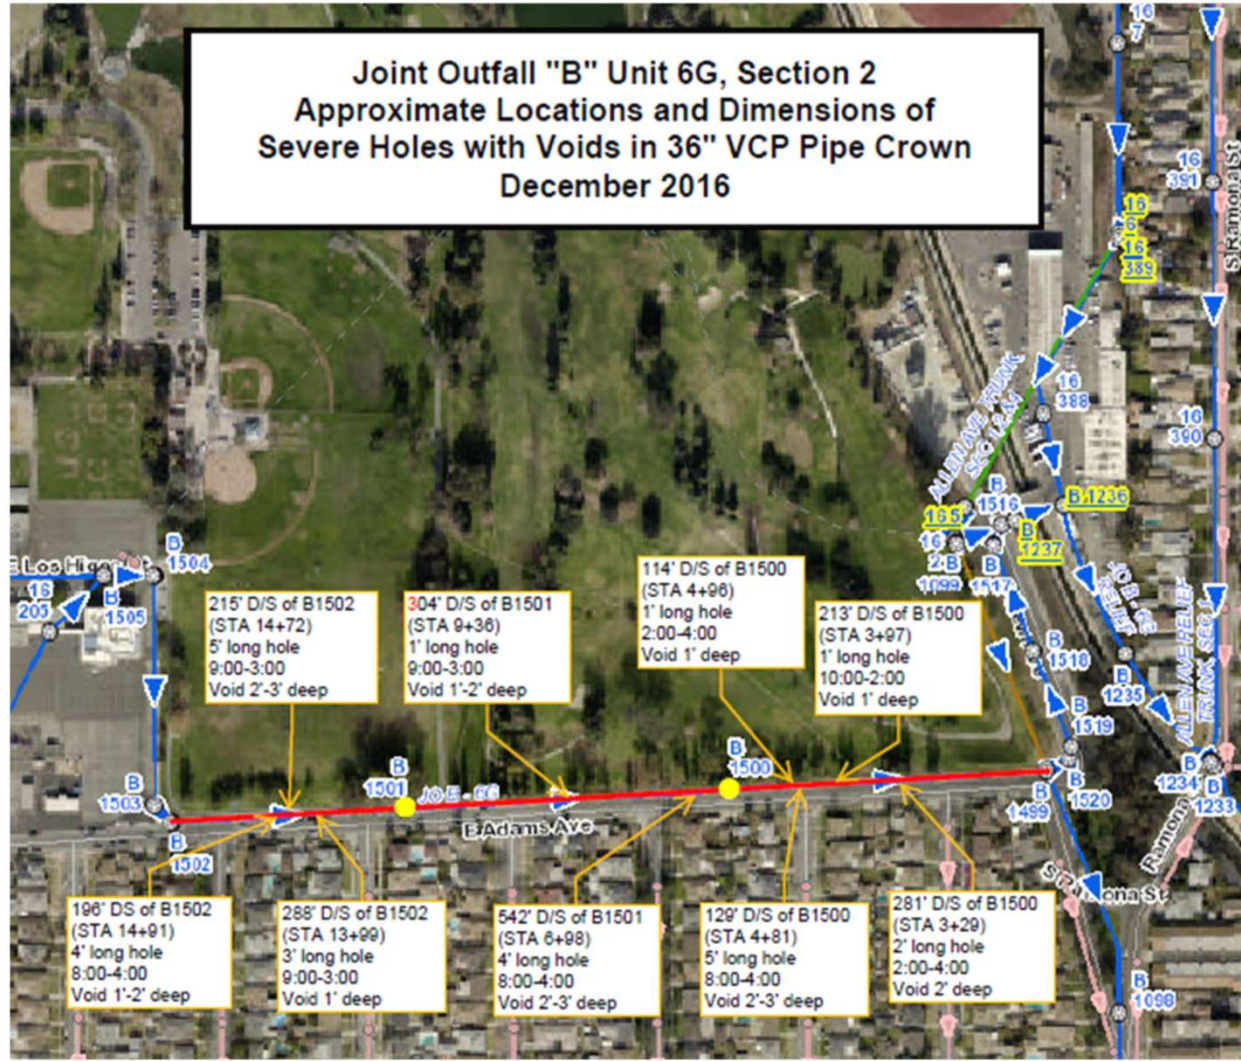
**Joint Outfall "B" Unit 6G, Section 2
Approximate Locations and Dimensions of
Severe Holes with Voids in 36" VCP Pipe Crown
December 2016**

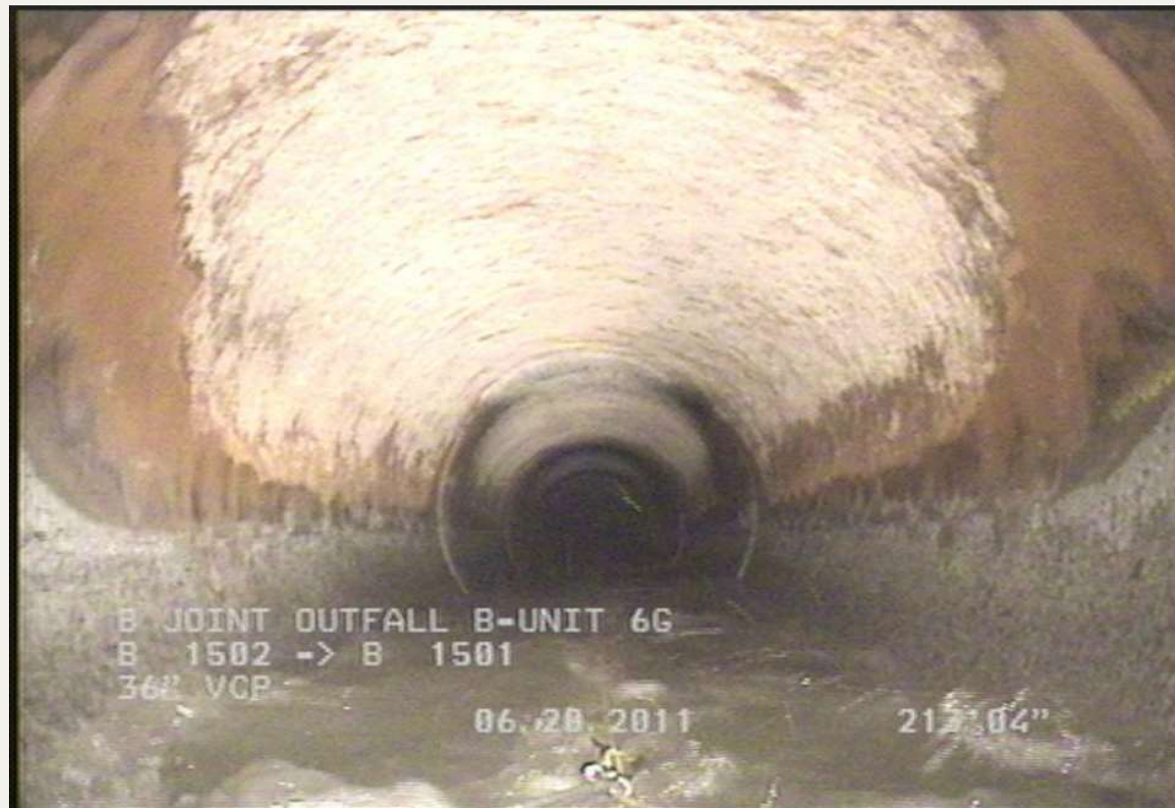
2011 INSPECTION OF 36" CLAY SEWER THAT FAILED IN 2016

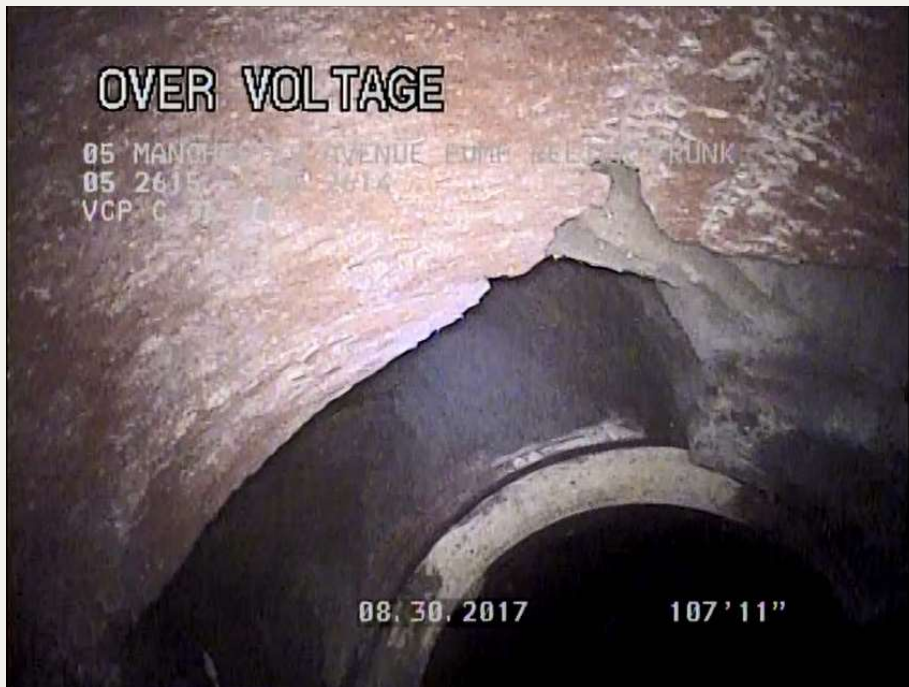
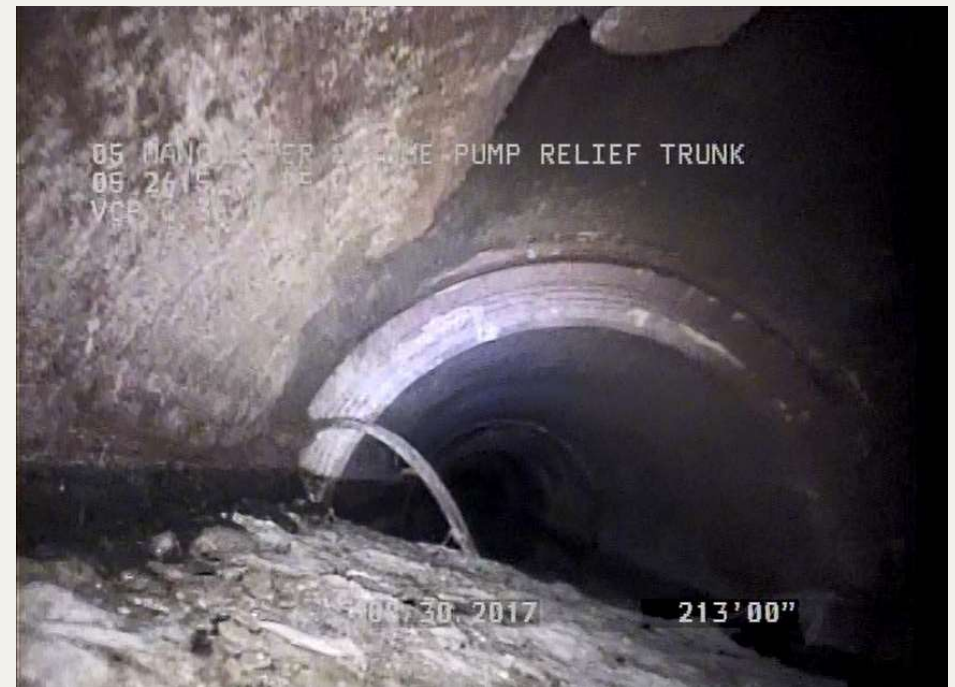
36" VCP SEWER IN THE CITY OF HAWTHORNE, BUILT IN 2007

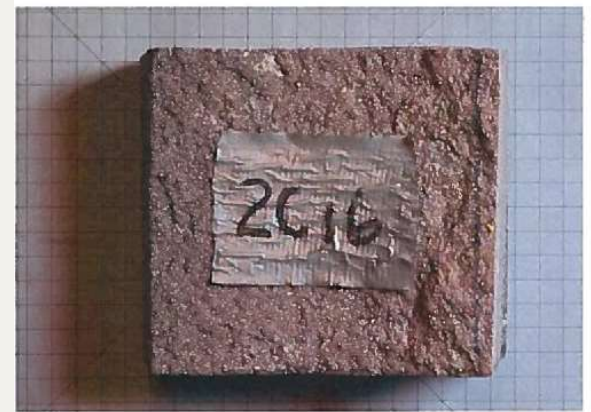
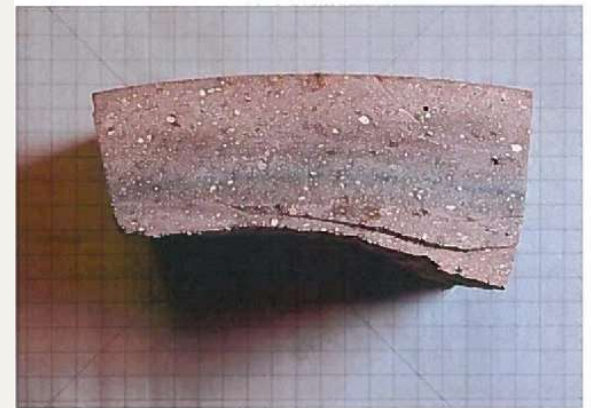
The formation of amorphous silica and gypsum throughout the VCP matrix, which expands and causes spalling.

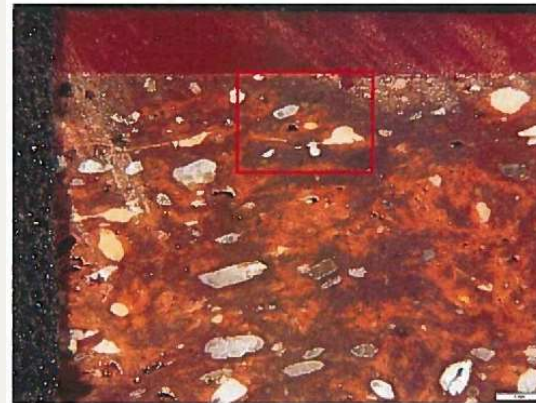
Photo 34

Sulfuric acid from the sewer environment deteriorates calcium silicate particles to amorphous silica

Polished section of Sample 2B20 (crown) at interior side near area depicted in Photo 29. Black tape is marker used to locate items of interest on the surface. Red epoxy seen at top was used to preserve the surface. Red box marks location of SEM/EDS element maps shown in Photo 35.

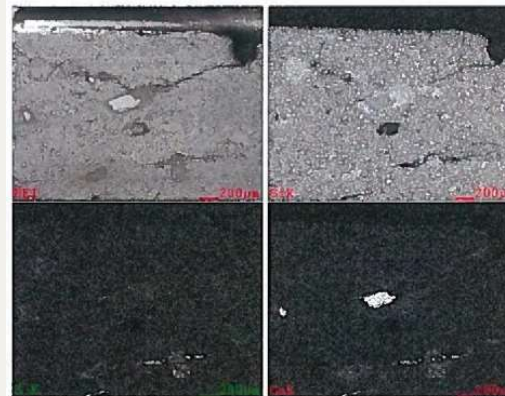
Photo 35

SEM BEI (upper left image) of area indicated in previous image of Sample 2B20 (crown), and SEM/EDS element maps of silicon (Si), sulfur (S), and calcium (Ca) of the same area. Particle in center has a calcium-rich core with a silicon shell. Near this particle, a diffuse distribution of silicon occurs in the matrix where a crack traverses to surface, and part of this crack contains calcium and sulfur. Calcium and sulfur are also present in a crack intersecting the top edge of a particle near the bottom of image, which also contains calcium and sulfur.

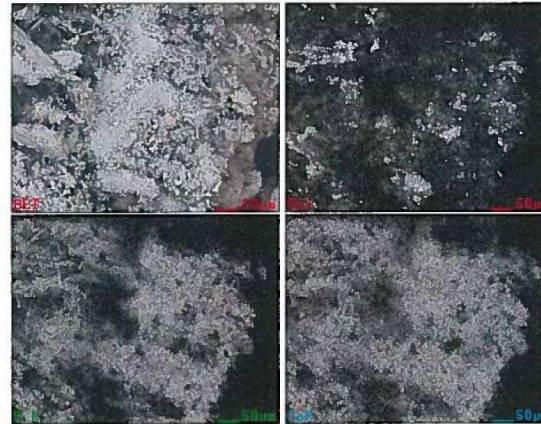
Photo 74

Both acid and water can dissolve calcium particles to form gypsum.

SEM BEI (upper left image) of particles in white extrudate obtained from Sample 2D17 (invert) after conducting ASTM C301 analysis with sulfuric acid, and SEM/EDS element maps of silicon (Si), sulfur (S), and calcium (Ca) of the same area.

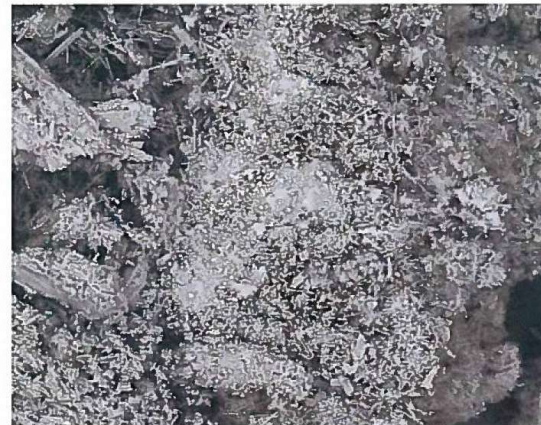
Photo 75

Enlargement of SEM BEI shown in Photo 74, showing long needle crystals of calcium sulfate (gypsum) and amorphous masses rich in silicon.
